# Lake Management Plan for Little Elk Lake Sherburne County, Minnesota

February 2002

Prepared for  
Little Elk Lake Association

Prepared by  
Steve McComas  
Blue Water Science  
550 South Snelling Ave  
St. Paul, MN 55116  
651.690.9602

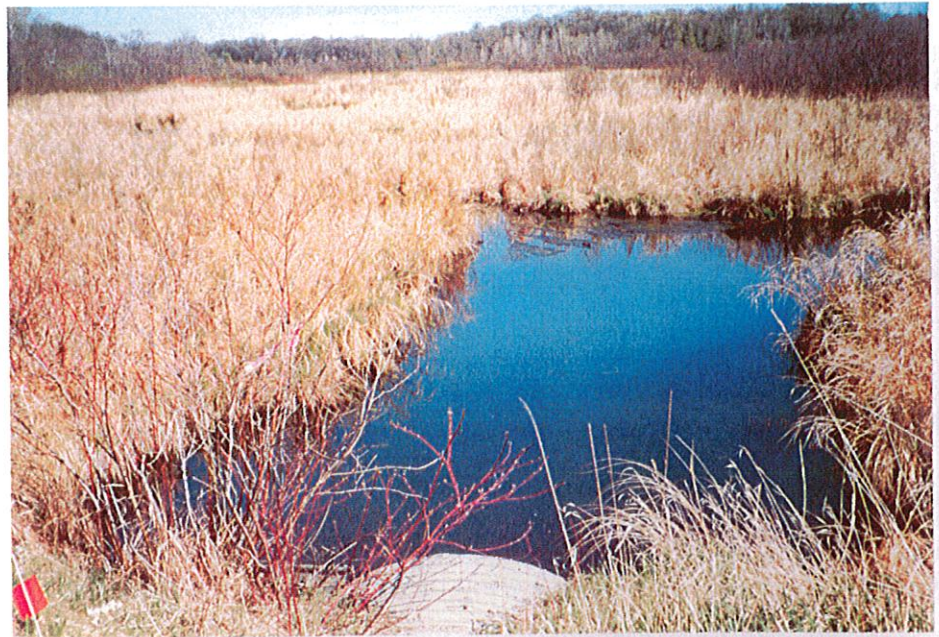
Battle Brook flows under County Highway 9 and into Little Elk Lake.

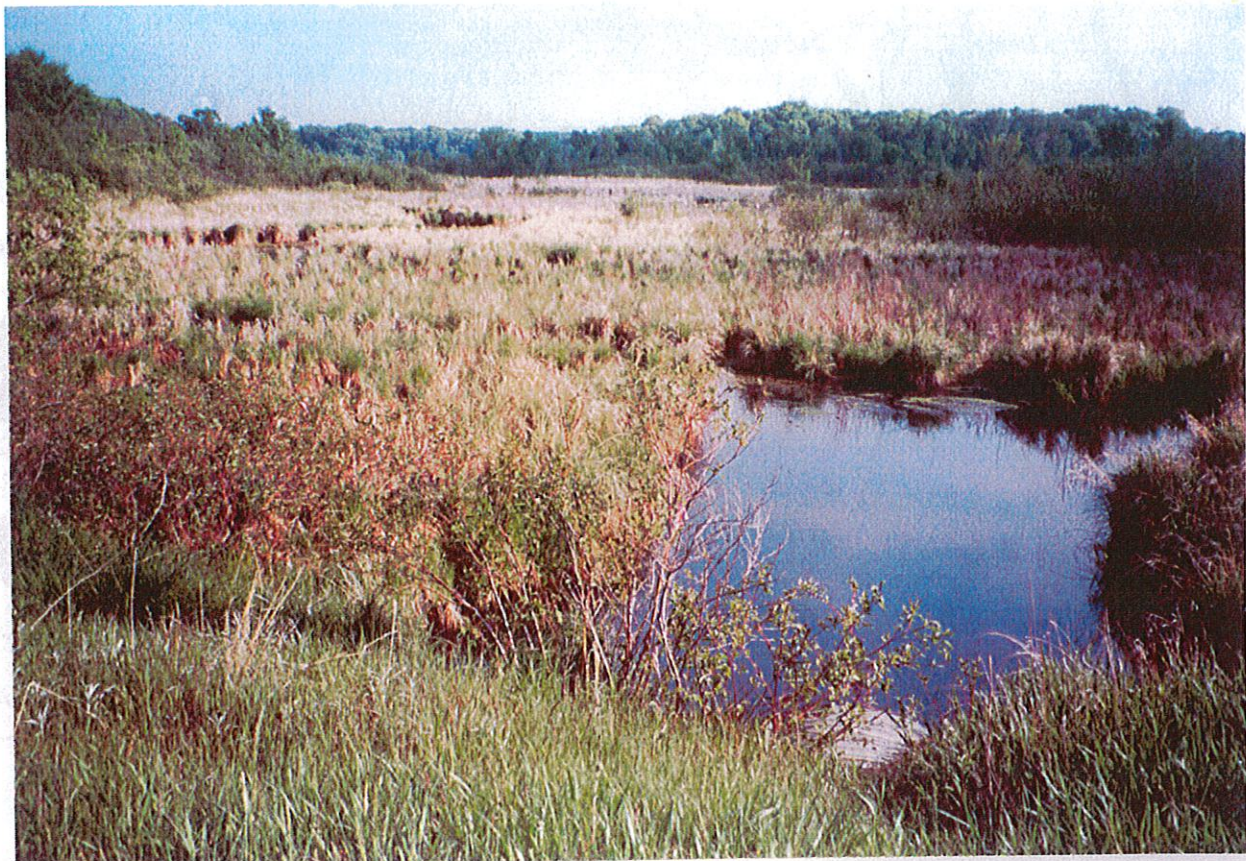
Typical wetland watershed setting. Battle Brook flows through this wetland system on the way to Little Elk Lake.

The drainage area represents the land area that sheds water into Little Elk Lake. The entire watershed area, as described by the Sherburne Soil and Water Conservation District is 20,599 acres. An outline of the watershed is shown in Figure 3. More than one half of the watershed drains to Rice Lake. The outlet from Rice Lake is Battle Brook. Battle Brook is the main tributary to Little Elk Lake.

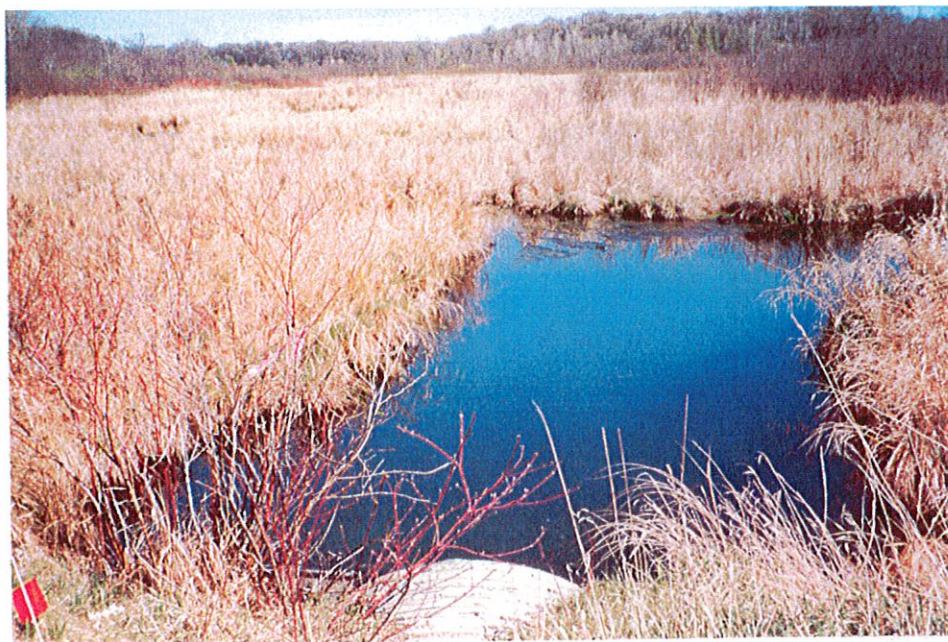
**Battle Brook is flowing under County 9 and into Little Elk Lake.**

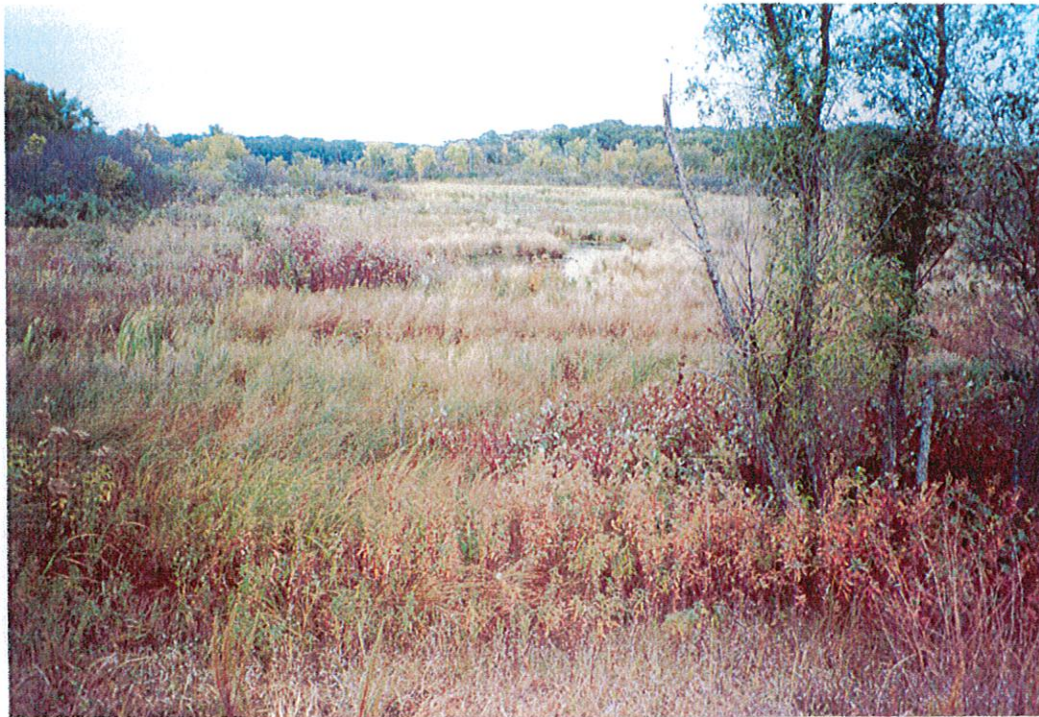
Open areas such as this in the Little Elk watershed generally export low amounts of phosphorus off the land.

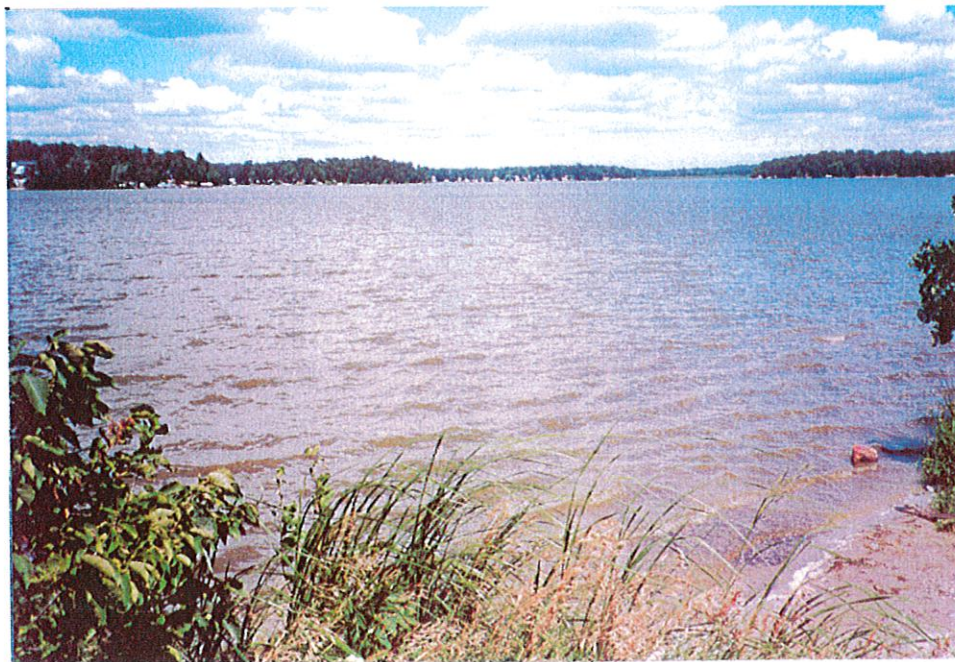
Little Elk Lake is a drainage lake meaning it gets most of its water from a stream source. It is relatively shallow and has a large watershed.

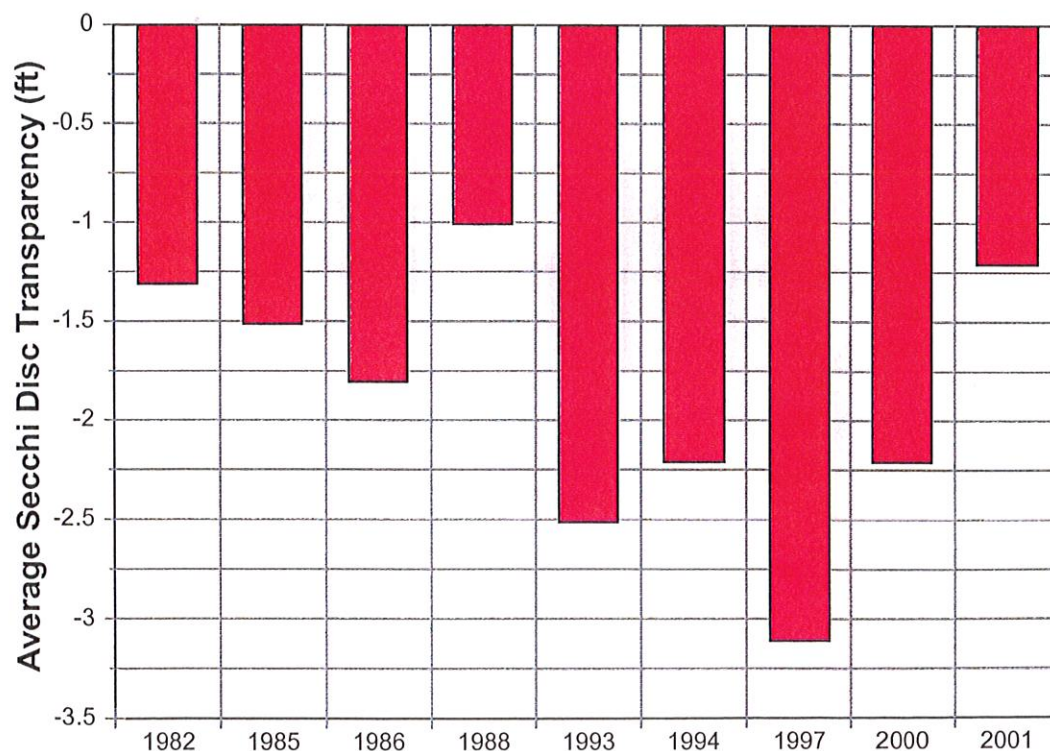
**Figure 6. Long term Secchi disc records for Little Elk Lake.**

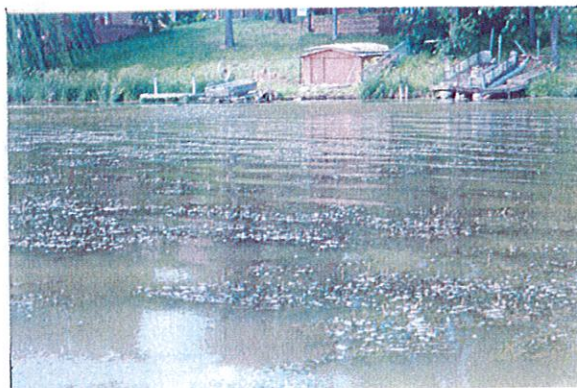
**Curlyleaf pondweed in Little Elk Lake, May 21, 2000.**

Currently it is found growing to the water's surface creating nuisance conditions in the north end and west side of Little Elk Lake and in several other areas. The nuisance extent is less than 30 acres. The management strategy is to implement a program to reduce the nuisance condition of curlyleaf pondweed. There are several options and include: herbicide use, mechanical harvesting, and/or boat-towed cutting.

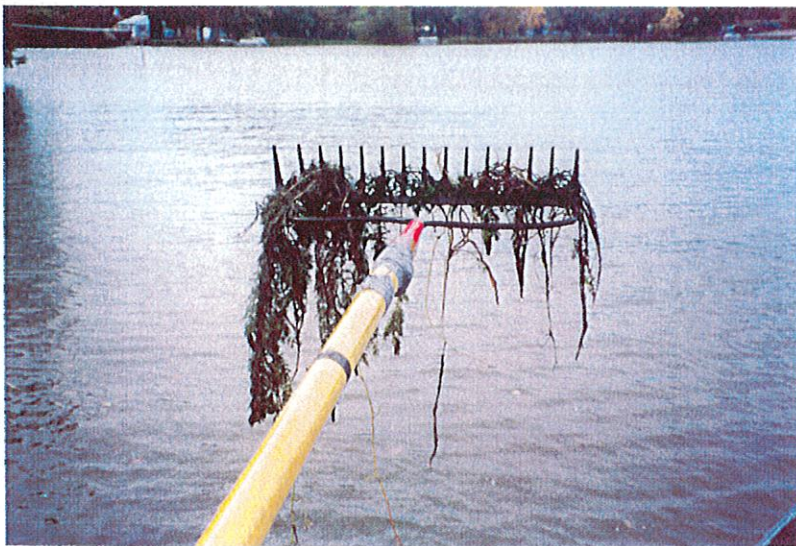
**Coontail, northern watermilfoil, and water stargrass all found on the sample rake and all found at a density of "1" on 9.29.00.**

In the second survey, conducted on September 29, 2000, curlyleaf was much more scarce, as is typical. The most common plants were coontail, northern watermilfoil, and water stargrass (Tables 13 and 14). Plants were generally found in low densities and no plants were found in the 5-8 foot depth range (Table 13).

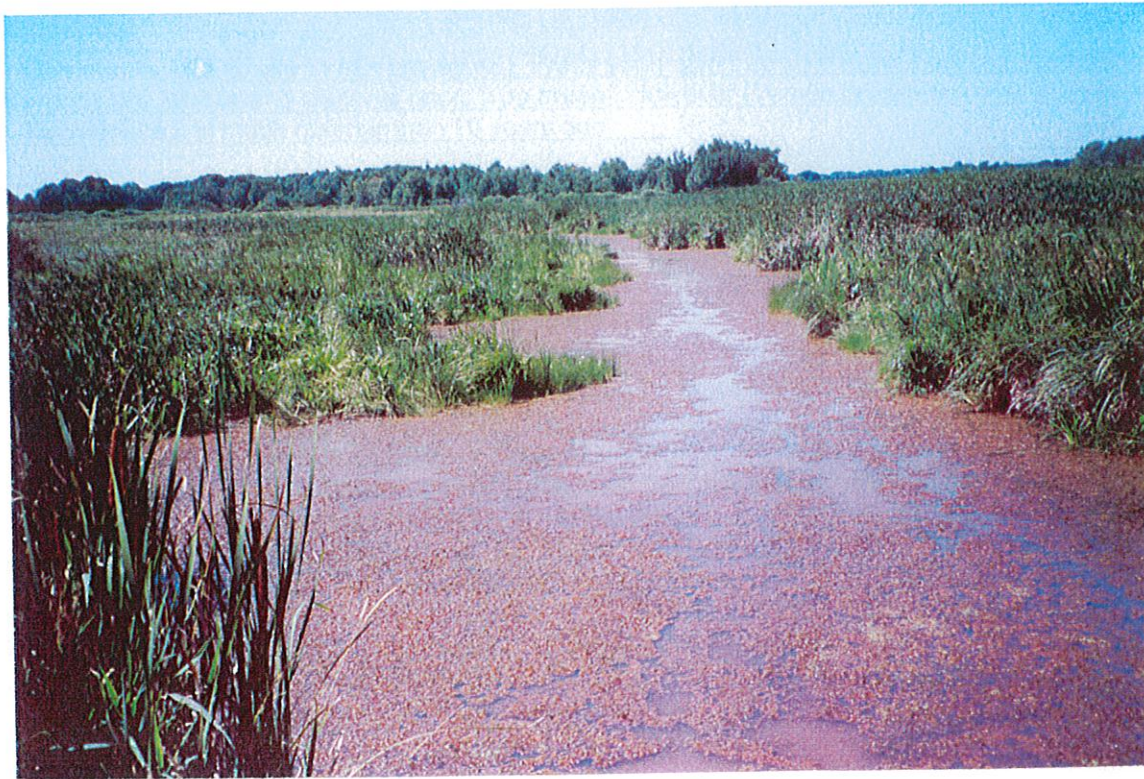
**In the upper watershed, much of the runoff goes through wetland systems. The Battle Brook water quality that comes out of these systems is relatively good.**

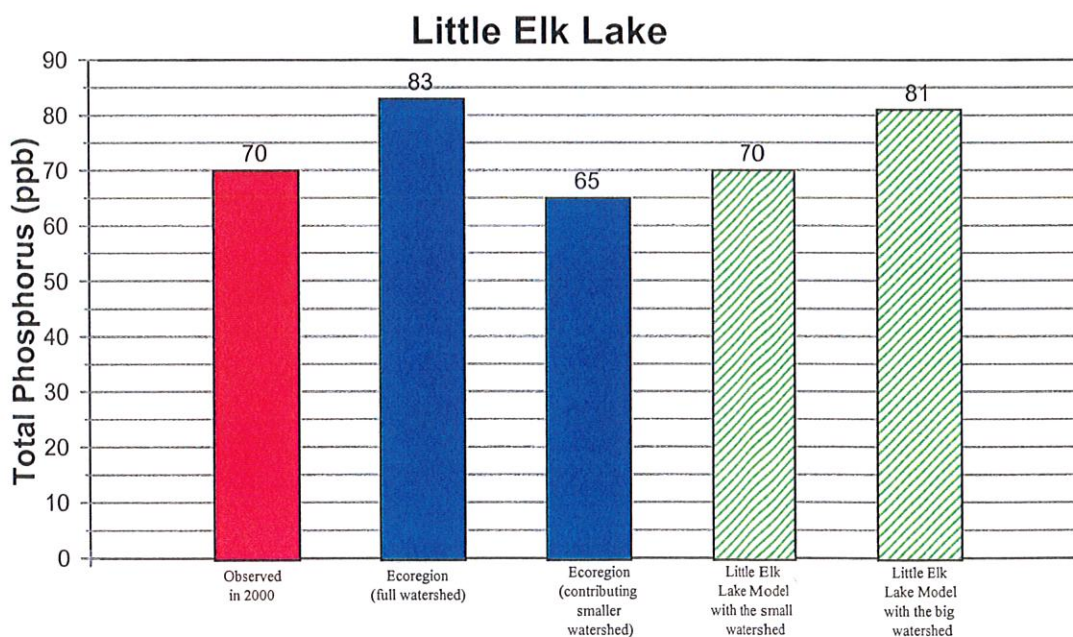
Figure 11. The above bars represent phosphorus concentrations in Little Elk Lake for several situations. The phosphorus concentration in 2000 was 70 ppb and the predicted lake phosphorus concentration was 83 ppb for a large watershed condition and 65 ppb for the smaller watershed using ecoregion values. Using Battle Brook phosphorus concentrations, we modeled Little Elk Lake using the full watershed and smaller watershed. The smaller watershed produced lower phosphorus concentrations.

Little Elk Lake is in the North Central Hardwood Forest Ecoregion. Glacial lakes are typical in this ecoregion and often their watersheds are about 10 times bigger than the lake surface. However, Little Elk Lake is not a typical glacial lake of the North Central Hardwood Forest Ecoregion. It has a watershed to lake surface ratio of 57 when using the full watershed and a watershed to lake surface ratio of 22 when using the watershed area south of Rice Lake. So although the water quality in Battle Brook is good for this ecoregion, because of the larger than average watershed, the phosphorus loading to Little Elk Lake is sufficient to create nuisance algae blooms. The result is the water quality of Little Elk lake is not as good compared to other lakes in the region with smaller watersheds.

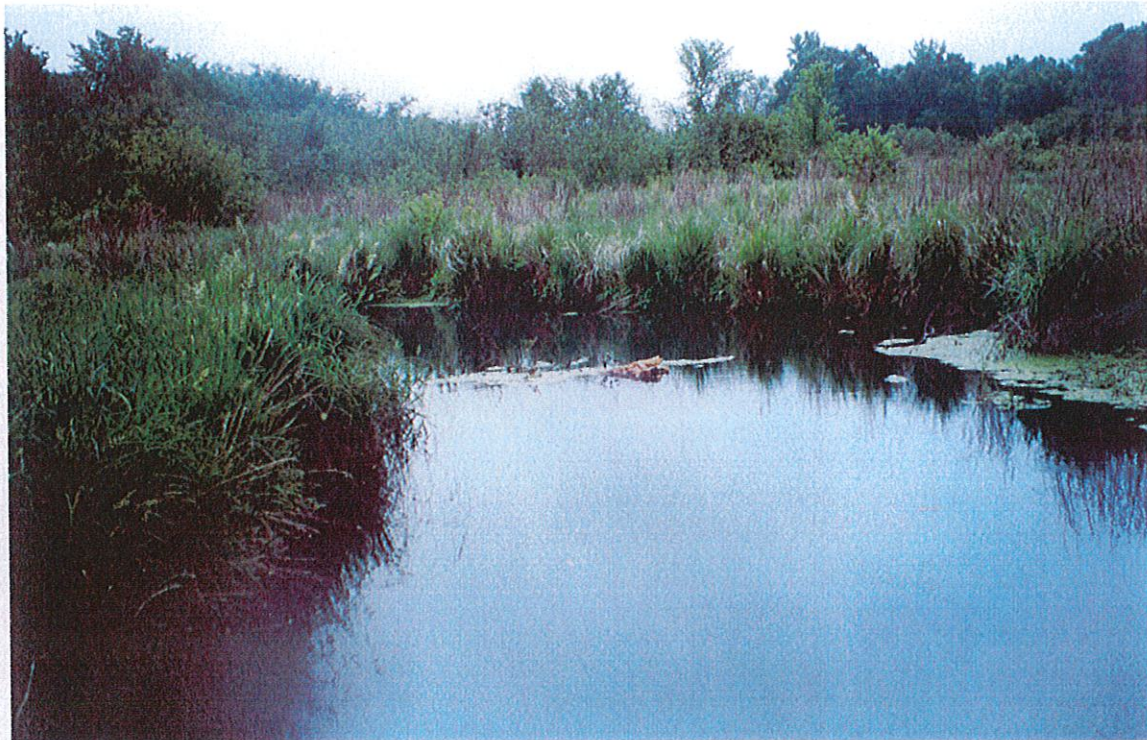
**A natural setting in the Little Elk Lake watershed. Stream is naturally buffered.**

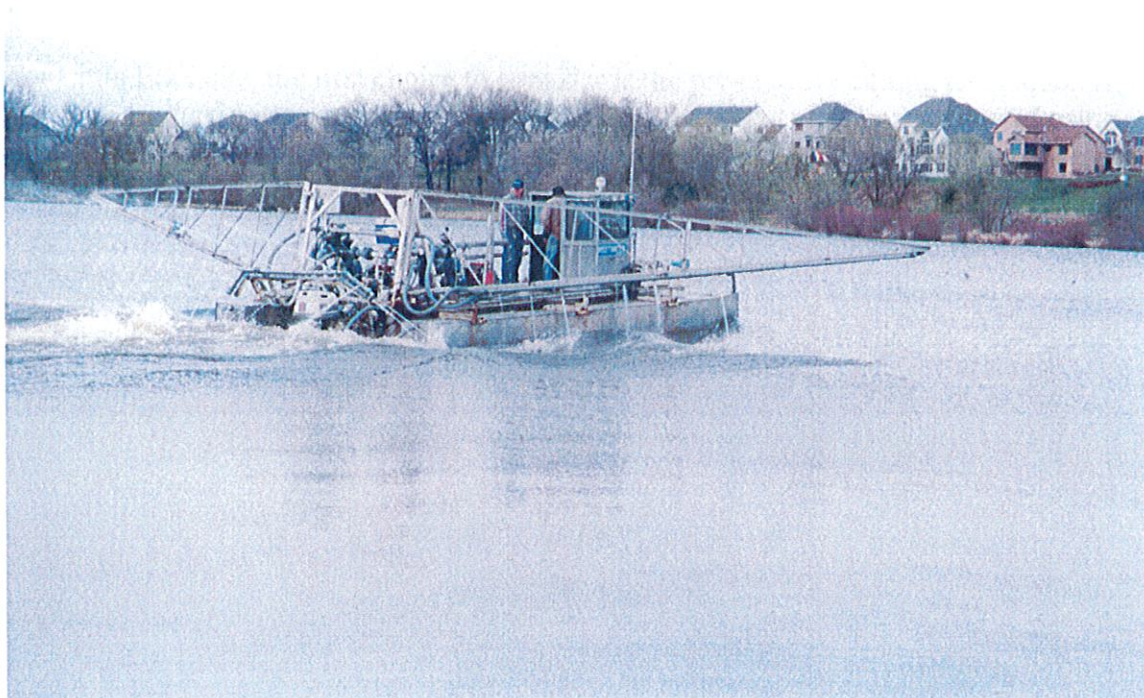
Figure 15. Alum application on Lake Susan, Chanhassen in 1998.

Alum is a compound composed of aluminum sulfate. It is a non-toxic chemical addition to lakes that controls algae by inactivating sediment-released phosphorus thus lowering the availability of phosphorus for algae growth. Alum is applied from a boat or a barge, usually in liquid form (Figure 15). Alum is most effective when phosphorus release from bottom lake sediments is documented to be a significant source of phosphorus to algae blooms. At this time lake sediments are suspected to be a phosphorus source but it is not documented. An initial step is to evaluate the potential for an alum application. The actual application would not be scheduled for several years. In the mean time, watershed and shoreland projects would be implemented. Alum may not be necessary. If it was to be applied in the future the cost could be about \$500/acre or about \$175,000.

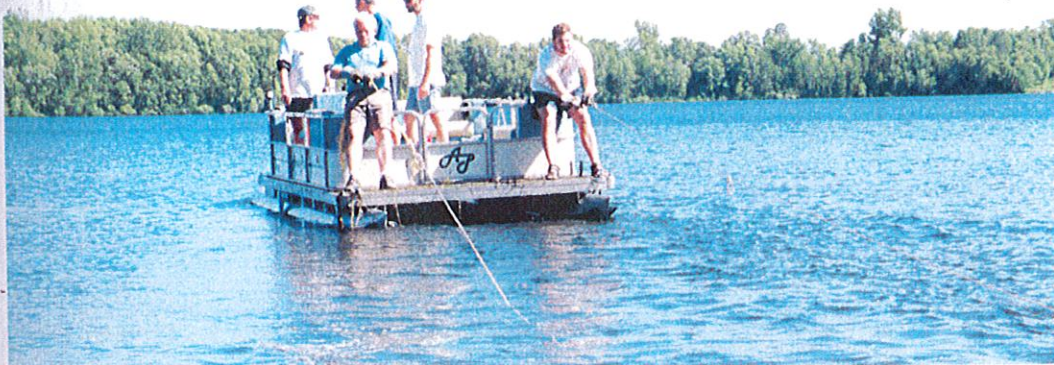
Figure 16. Weaver Lake cutting crew at work in 1998 cutting curlyleaf pondweed. The Little Elk Lake Association could organize a similar effort if they wanted to control curlyleaf.

For Little Elk Lake, the first choice to consider is the pre-emptive cutting technique. It involves organizing a half dozen or more teams of 2 to 3 people to cut curlyleaf pondweed using a boat-towed, 6-foot wide cutter (Figure 16). A curlyleaf pondweed checklist is shown on the next page and a map of curlyleaf distribution is shown in Figure 17.

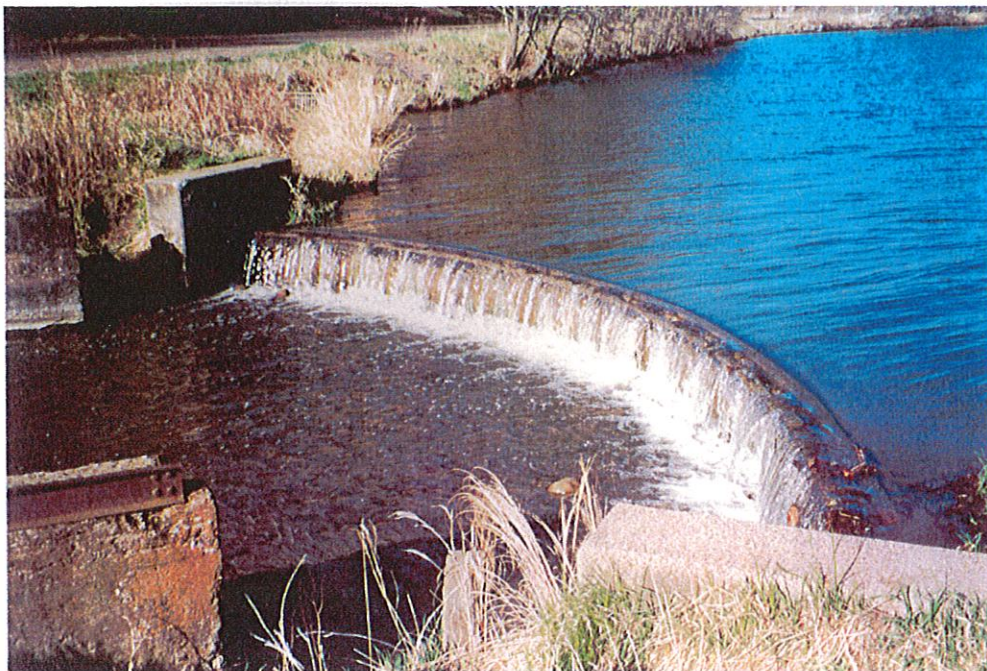
**The existing water level control structure only holds back about 2 feet of water. To lower Little Elk Lake further would require pumping.**

For Little Elk Lake, the first step would be to evaluate the feasibility of a drawdown from an environmental, economic, and lake user perspective. After a feasibility study and lake meetings, a decision would be made on a drawdown project. The lake would have to be pumped to drain it. It is estimated that pumps would be used for around 50 days at a cost up to \$1,000 per day. The total drawdown project could cost up to \$50,000.
